Too much water

Box Creek

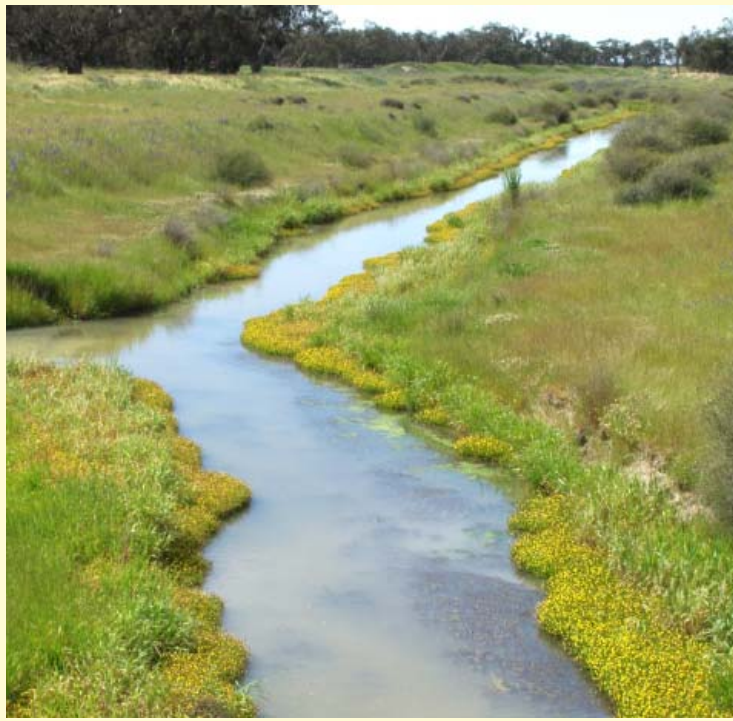
The Bucyrus Erie dragline excavators which built the Mulwala Canal also built the Box Creek stormwater escape system during the late 1950s.

Three natural flood runners ~ the Box Creek, Union Creek and Baratta Creek ~ were connected together to more effectively drain stormwater and provide a safety valve for flows in the Mulwala Canal.

Box Creek originated on the northern side of the Mulwala Canal at Blighty. In 1992 the Box Creek Drainage Channel was built, draining land on the southern side of the Mulwala Canal between Finley and Blighty.

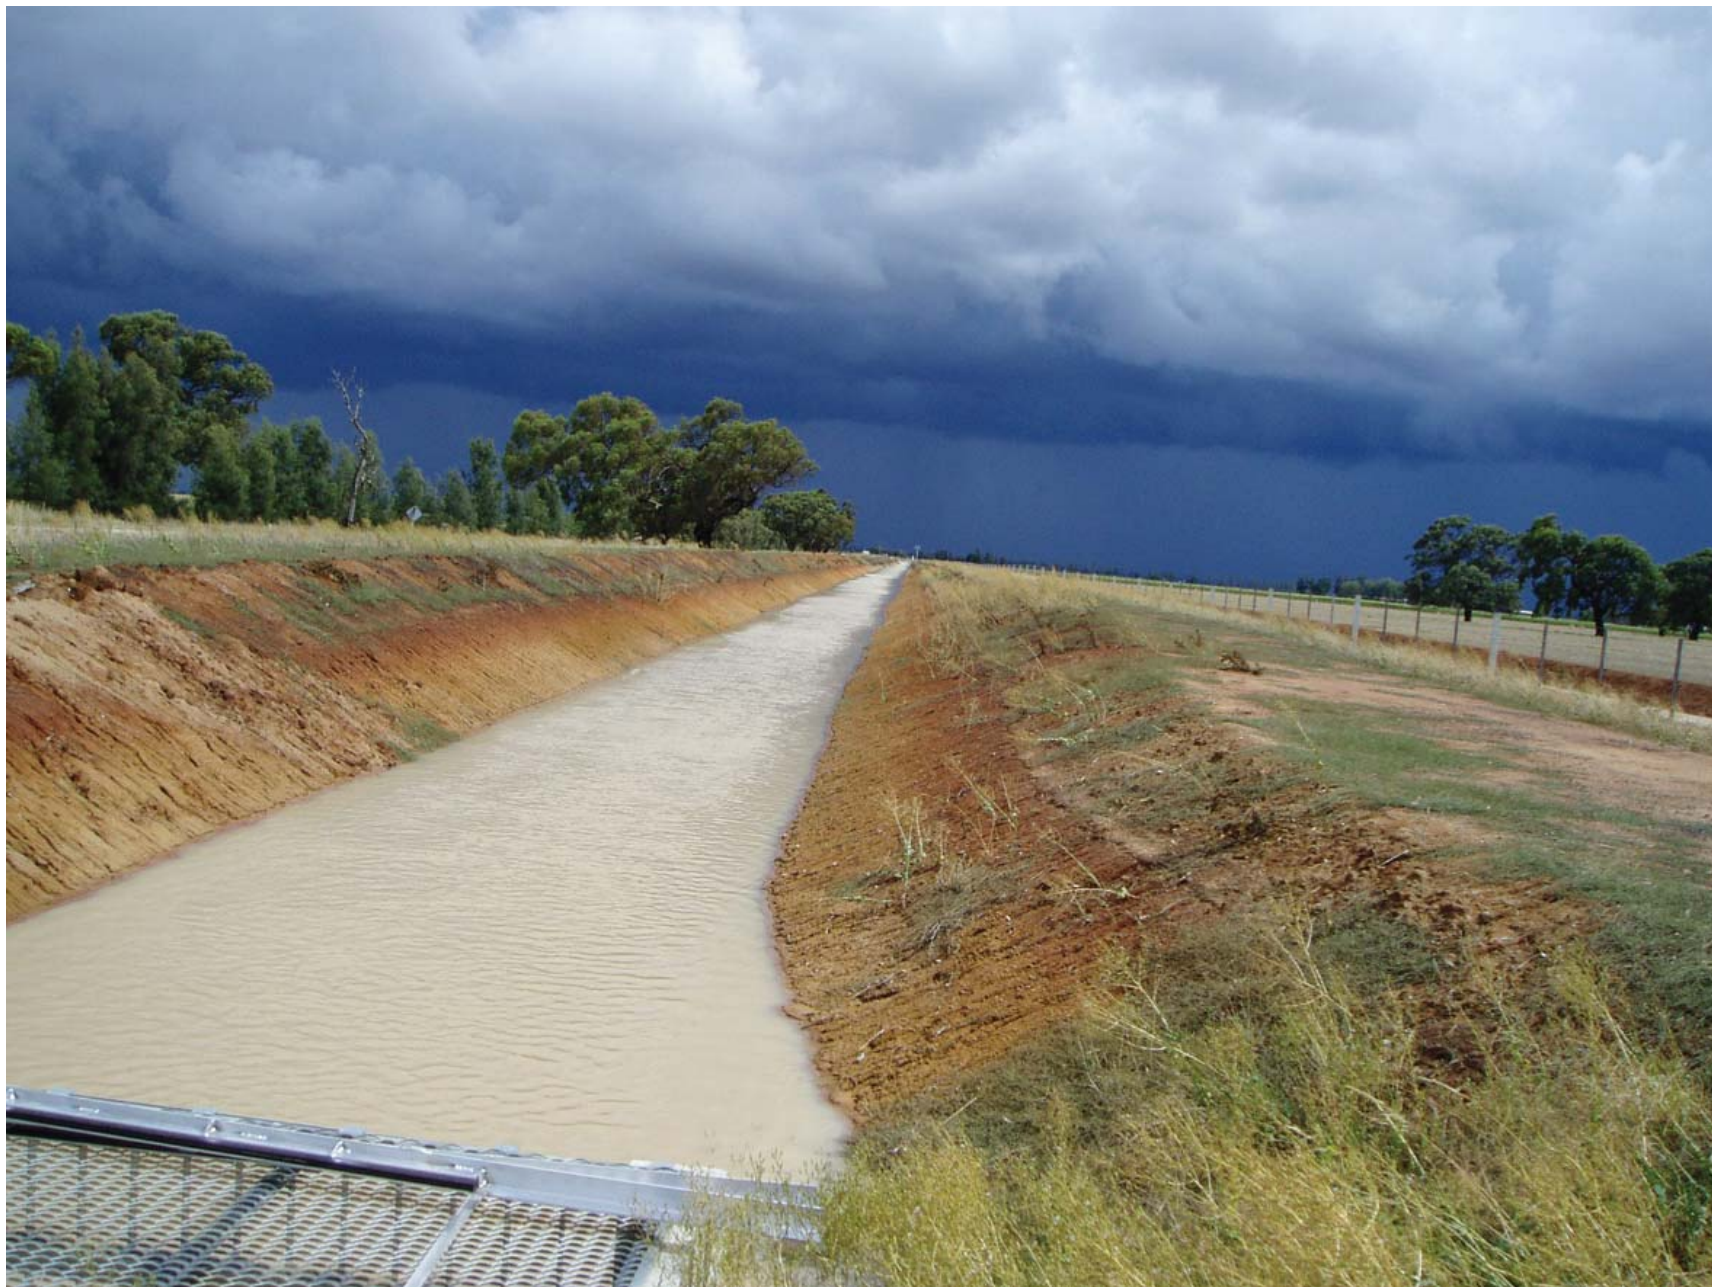
The Booroobanilly stormwater escape system in the Berriquin district flowed following heavy rainfall in February 2005. Photo: MIL Collection
